USATECOM PROJECT NO. 7-3-0239-09

INTEGRATED ENGINEERING AND SERVICE TEST OF
EFFLUENT FUEL TESTER

FINAL REPORT

U S ARMY
GENERAL EQUIPMENT TEST ACTIVITY
FORT LEE, VIRGINIA

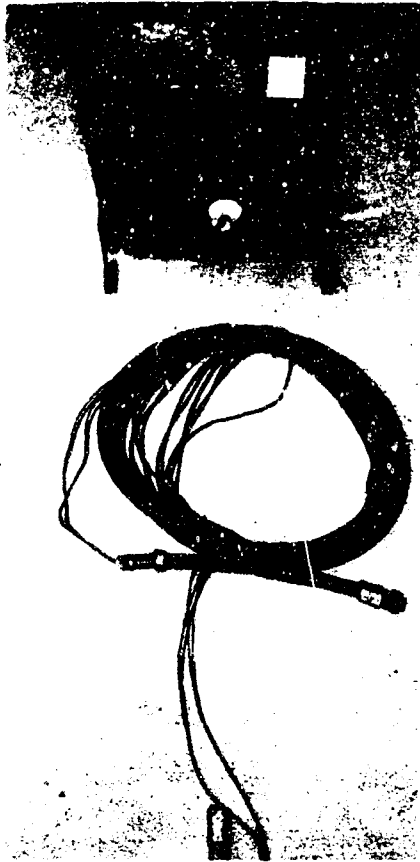
Amplifier component with chart recorder and alarm bell.

Figure 1. Major components of effluent fuel tester.

e. Test operations showed the amplifier component, with alarm bell and chart recorder, to be very bulky, difficult to handle, and subject to damage as presently mounted on the plywood frame. These three components should be mounted in a lightweight protective carrying case.
